**Savannah River
Remediation**

SRS Liquid Waste Tank Integrity and Inspection Program

Kent Fortenberry
SRR Chief Engineer
October 9, 2014

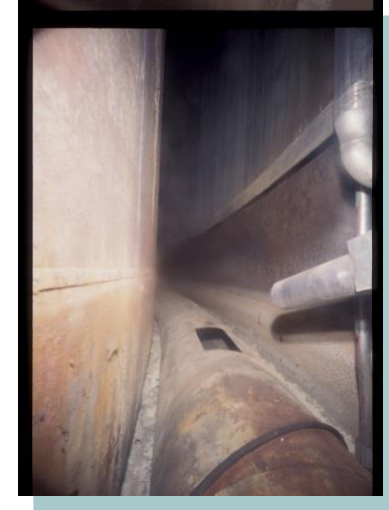
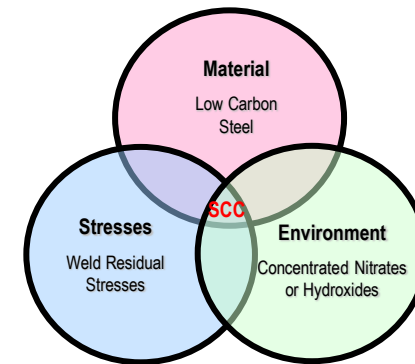
- Primary modes of observed degradation are general corrosion, corrosion pitting, and stress corrosion cracking
- Nitrate-induced stress corrosion cracking (SCC) is observed near fabrication welds or repair welds in Type I/II Tanks
- Most observed degradation occurred early in service in non-stress relieved Type I/II Tanks
- Type III Tanks have no known leaksites
 - Better materials of construction
 - Post-weld heat treatment to relieve weld residual stresses
- Corrosion control program to preclude further degradation

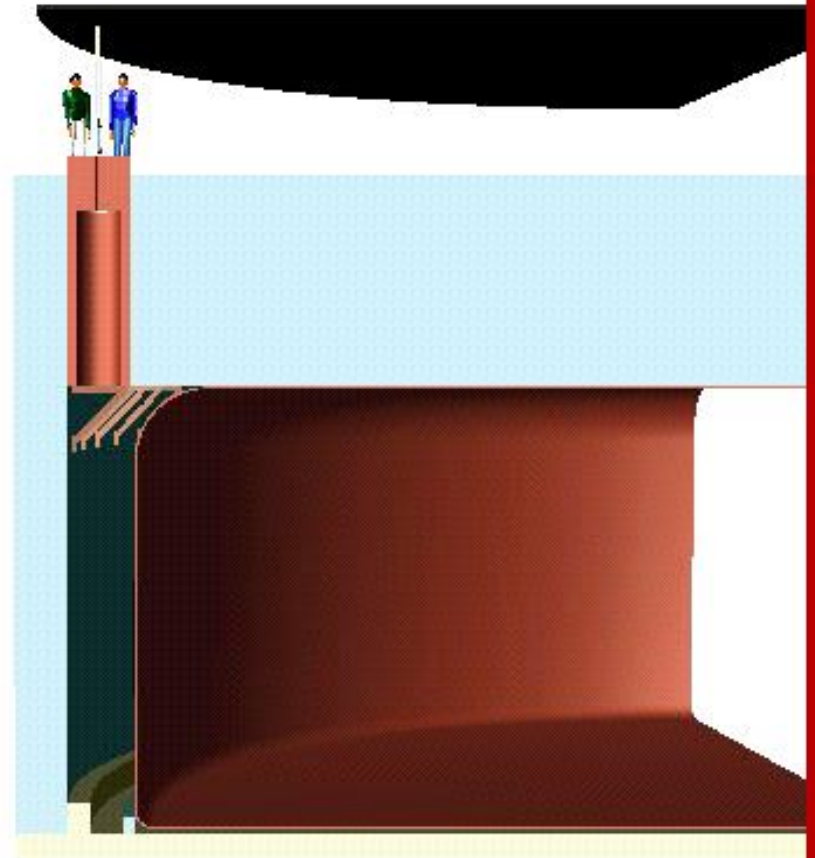
Probe travels over
1 mile during a tank
inspection

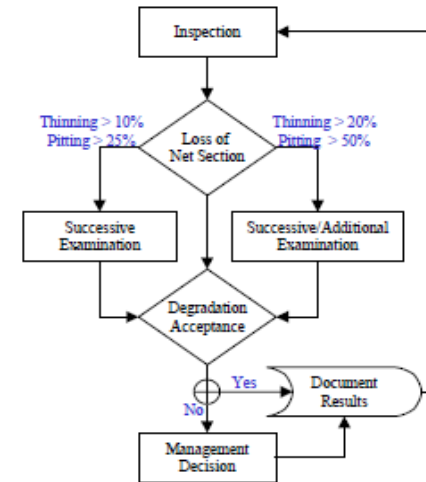
Figure 2: Decision Logic for Disposition of General Thinning, Pitting, and Local Thinning

- General Thinning
- Local Thinning
- Pitting
- Service Induced Flaws (cracks)
